CONDITION ASSESSMENT

Project: **Conway Public Library**
15 Greenwood Avenue
Conway, NH 03818

Date: June 9, 2022

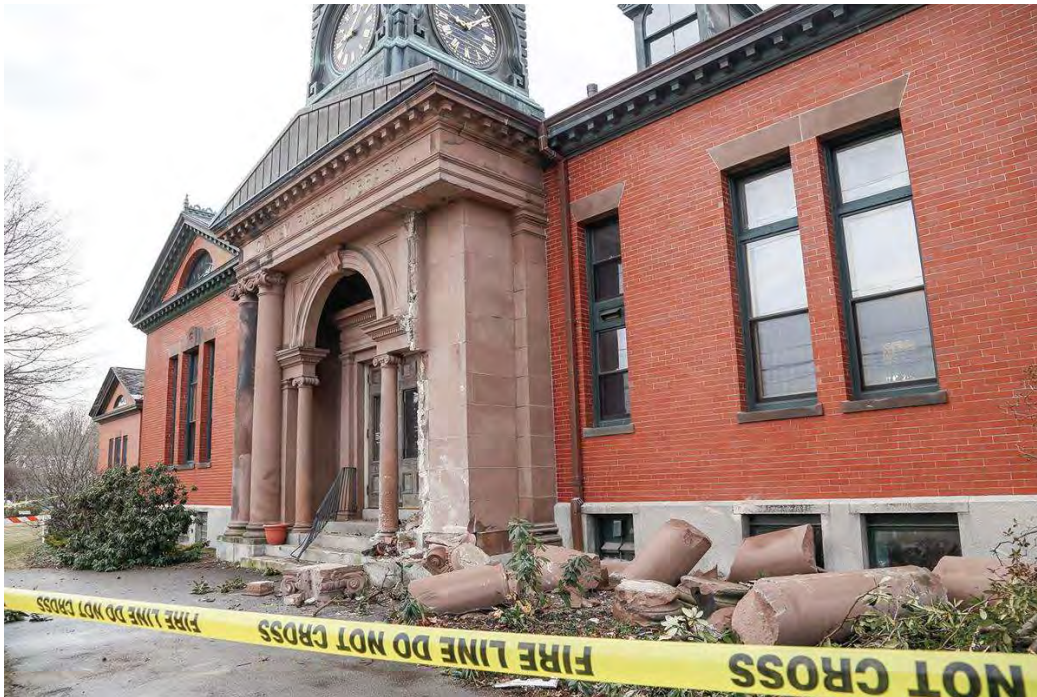
Figure 2. Conway Public Library accident aftermath.

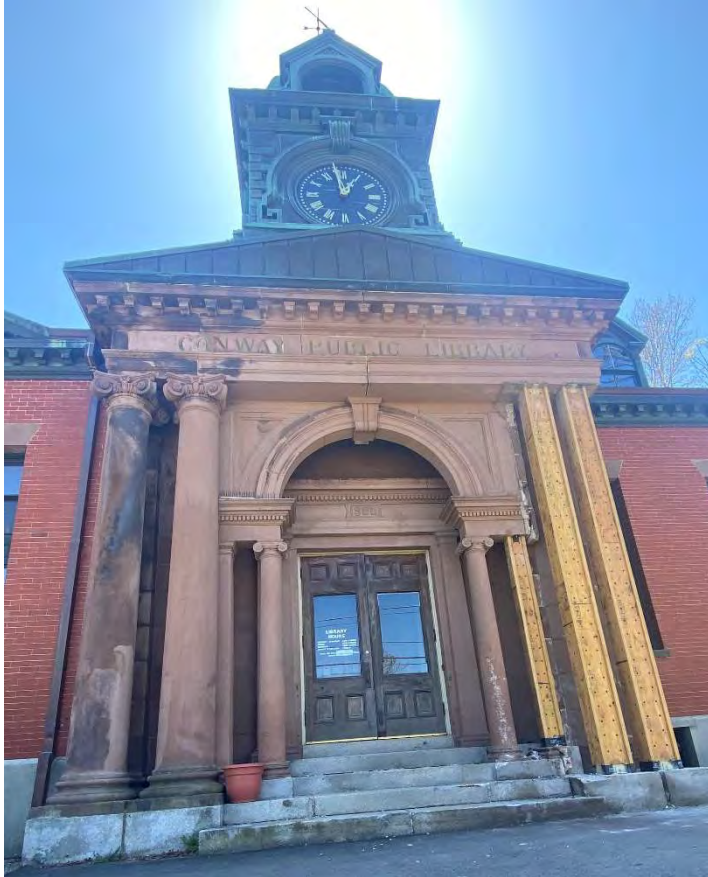
- The most considerable damage to the facade are the two missing brownstone columns and one missing engaged pilaster on the west side (Figure 3). Pieces of broken brownstone are stored either inside of the Library or at the Town Garage. The missing engaged pilaster was keyed into the brownstone facade every other brownstone unit course vertically. As a result, every other unit of brownstone in that area has an uneven broken edge (Figure 4).

Figure 3. Location of missing brownstone columns at west side of Conway Public Library entrance.

- Remove the temporary wooden posts, one at a time, once the repaired column and pilaster elements are ready for installation. Reinstall column capitals and bases and install fabricated cast stone column shafts with a layer of historically-appropriate mortar between each successive unit. Ensure adequate temporary structural support of the entablature between the period when the wooden posts are removed, and the combination new/repaired columns are installed.

- Reinstall original pilaster capital, repairing as needed, and install new cast stone pilaster shaft, keying into the brownstone facade, like the original pilaster. Install a layer of historically-appropriate mortar between each successive unit. Ensure adequate temporary structural support of the entablature between the period when the wooden post is removed, and the combination new/repaired pilaster is installed.

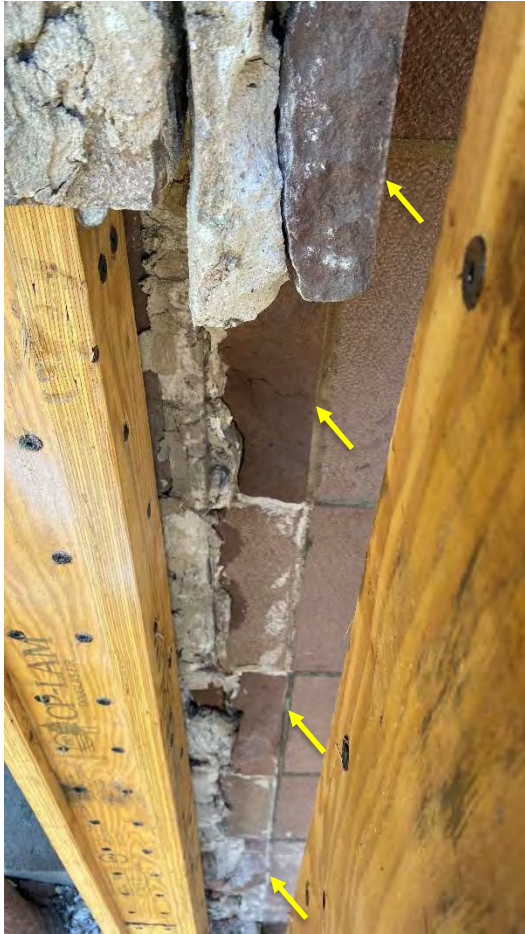
Figure 4. Broken edges of keyed units in backup brownstone masonry.

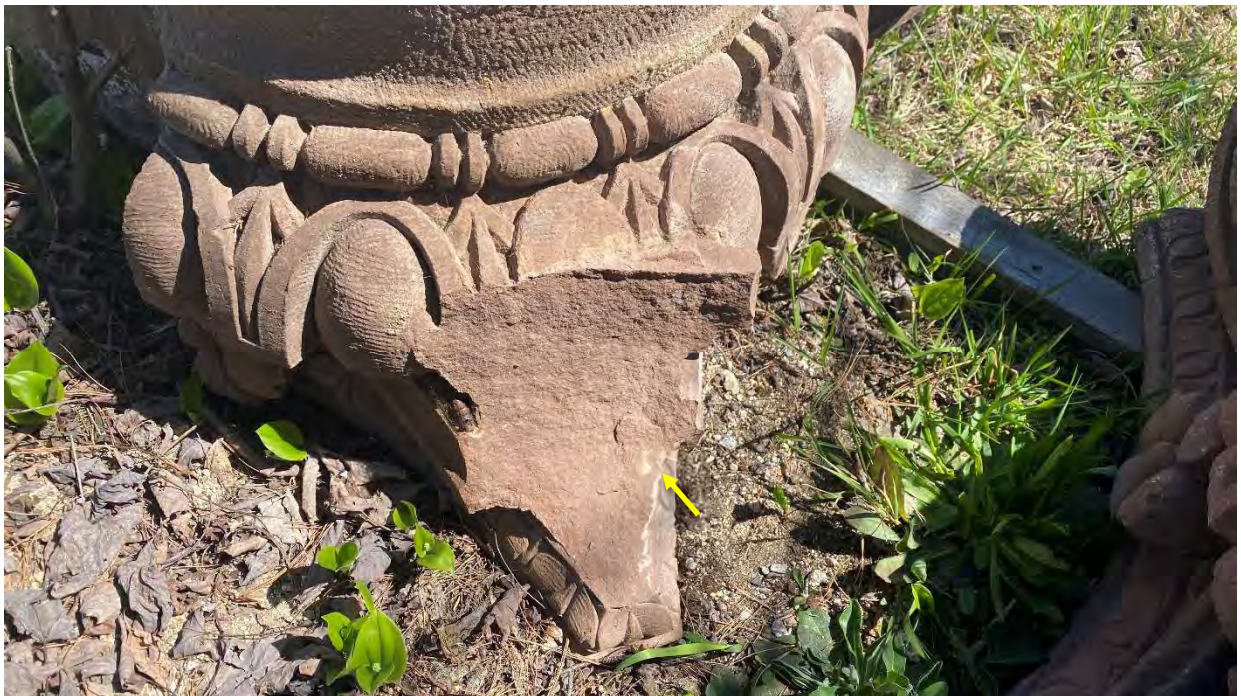
- The two fallen column capitals are largely whole, with a few spalled sections. The largest spalls are the scrolls on the back face of the capital (Figure 5). The capitals have a layer of mortar intact on the bottom surfaces (Figure 6).

- The column capitals can likely be reused, with poured brownstone patches at the spalled pieces. A mold of the most intact brownstone elements can be made to reproduce spalled areas (such as the broken scrolls) with a poured patch product to replicate the brownstone. The poured details can then be anchored to the original brownstone with an appropriate anchor system. An alternative to this option includes installing a brownstone dutchman repair. A dutchman repair involves using matching brownstone, carving it to match the original detailing, and anchoring it to the parent stone using a mechanical anchor. This alternative is less feasible because it is much more difficult and time-consuming to find a qualified contractor to carve stone than it is to find a mason to create a mold and pour a patch repair.

Figure 5. Spalled scroll from back side of column capital.

- Have engaged pilaster shafts fabricated in cast stone to replicate the dimensions and stippled carved surface texture of the originals.
- Have a mold taken of the most intact sections of the column capitals to be replicated. Create patch repairs for the spalled areas using the mold. Install the patch repair against the parent stone with a mechanical anchor (recommended by a structural engineer).

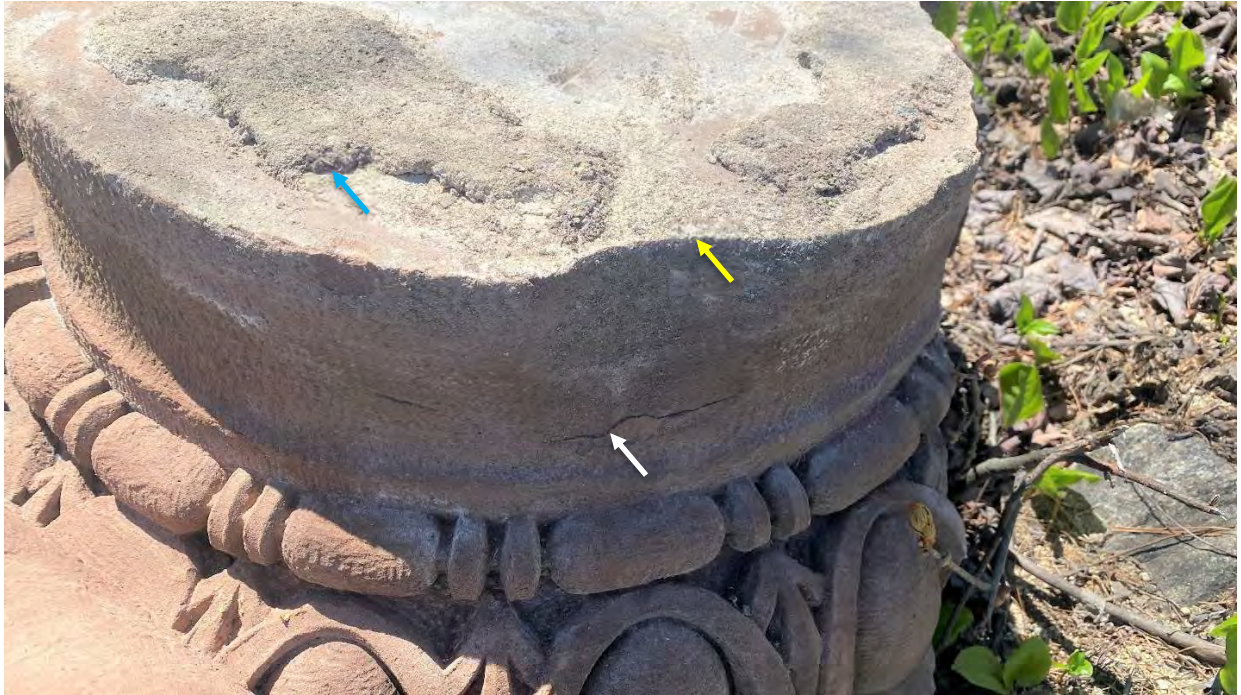
Figure 6. Spall (yellow arrow) and crack (white arrow) in column capital. Mortar (blue arrow) on bottom surface of capital.

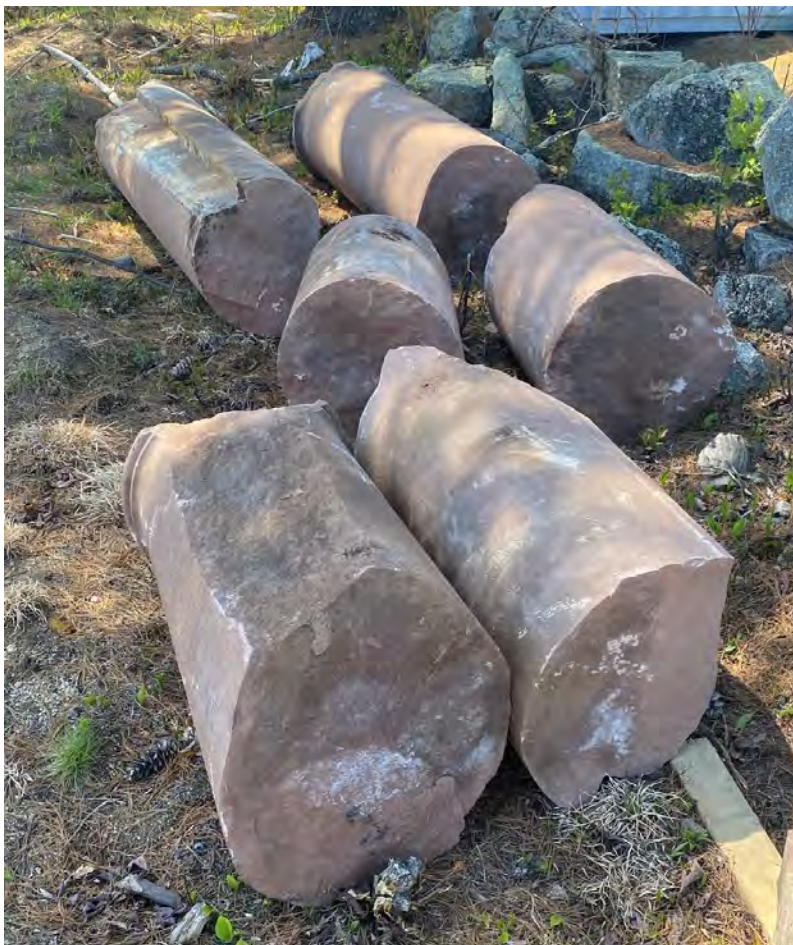
- The fallen column shafts broke into several pieces – roughly three large pieces per column (Figure 7). The breaks occurred largely on horizontal planes, but are on a slight angle.

- Reinstalling the column shaft pieces is possible but would be more difficult and likely less durable than having replacement column shafts fabricated out of cast stone. In order to reinstall the original brownstone shafts, the center of each piece would likely have to be cored out, creating a vertical cylindrical shaft to embed a metal anchor rod through to provide continuous support and bed in an appropriate sealant or mortar. This anchor rod could be fed through all of the shaft pieces to provide continuous support through the broken elements. This installation may also require a metallic anchor embedment at the sill and head of the columns. Introducing metallic elements introduces potential for additional means of masonry deterioration. If any water enters the system, metallic elements can corrode, which causes the metal to expand and adjacent stone to spall or crack.

If column shaft pieces are reinstalled mortar would have to be installed between shaft pieces. This mortar would have to be specially formulated to match the color of the brownstone. Even a close mortar color match layered between pieces of brownstone will be visually apparent. Therefore, either aesthetics would have to be sacrificed, or a layer of a patch material could be applied around the whole surface of the column shaft to match the brownstone color. An applied coating will require more regular maintenance to be performed.

For all of these reasons, a cast stone product column shaft replica would likely be the most effective option.

Figure 7. Broken pieces of column shafts.

- Similarly, complete patch repairs on column bases. Mechanical anchors are not required in this application as the patches are not overhead.
- Have column shafts fabricated in cast stone to replicate the dimensions and stippled carved surface texture of the originals. We recommend requiring the manufacturer to send samples and/or mockups of the cast stone to the library to be reviewed in different types of lighting to make sure they are a good match to the existing original brownstone.

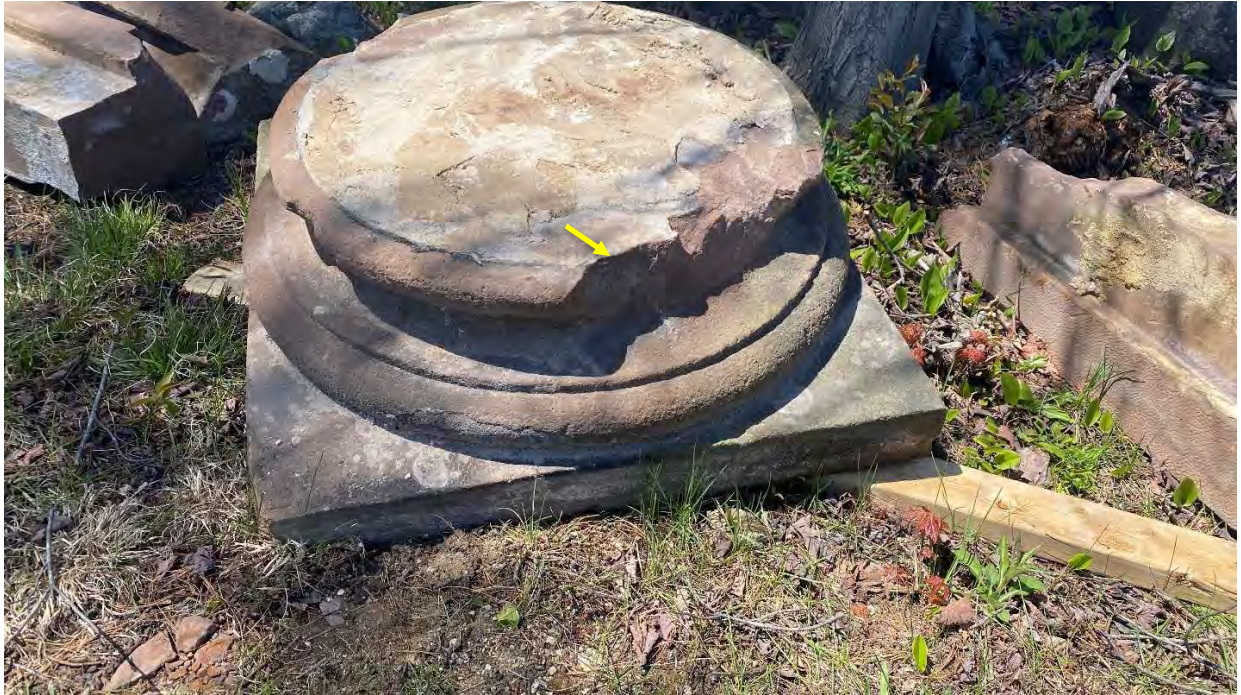
- The column bases were largely intact with some spalls along the top (a maximum of roughly 20% of the top is spalled) (Figure 8). The bottom of one of the engaged brownstone plinth elements was also spalled (Figure 9). The column bases also have some mortar intact on the top surface.

- The column bases can also likely be reused, but either patch or dutchman repairs would have to be made to fill in where brownstone has spalled. Again, a patch repair is likely the best method for the reasons outlined above.
- Since the railings installed at the time of the accident were more modern, the library could consider a new railing design to match the design of the original construction.

Figure 8. Spall at top of column base.

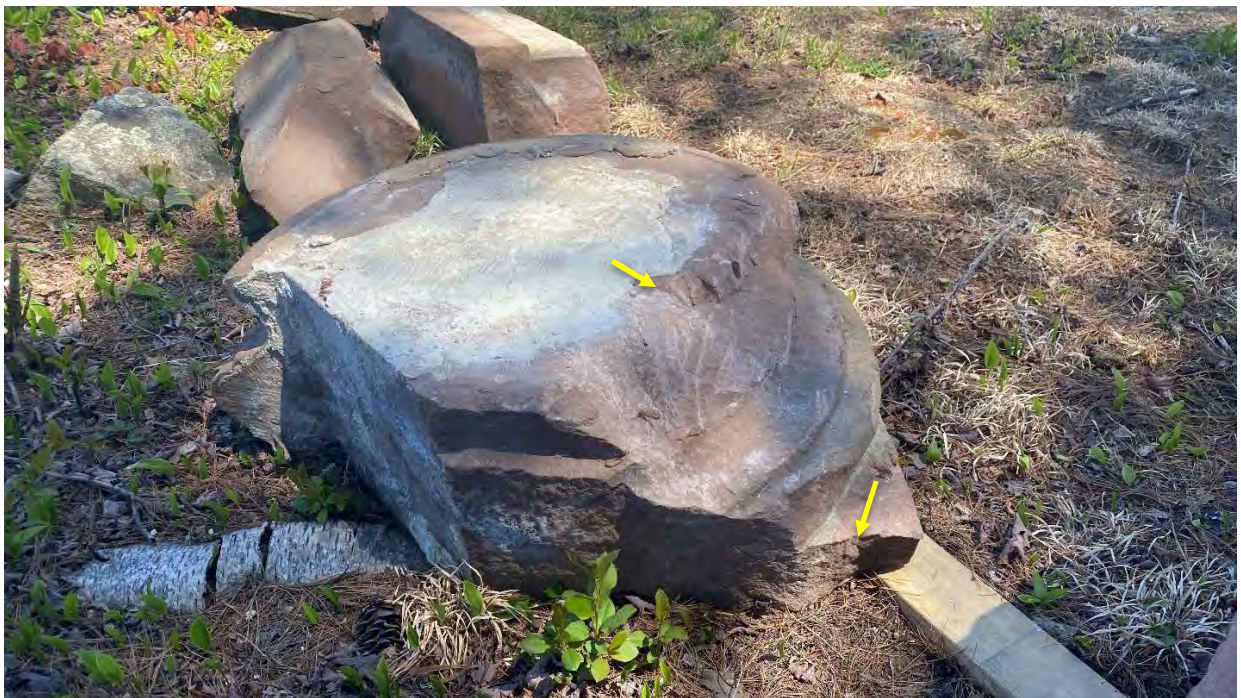
Figure 9. Spall at top and bottom of column base.

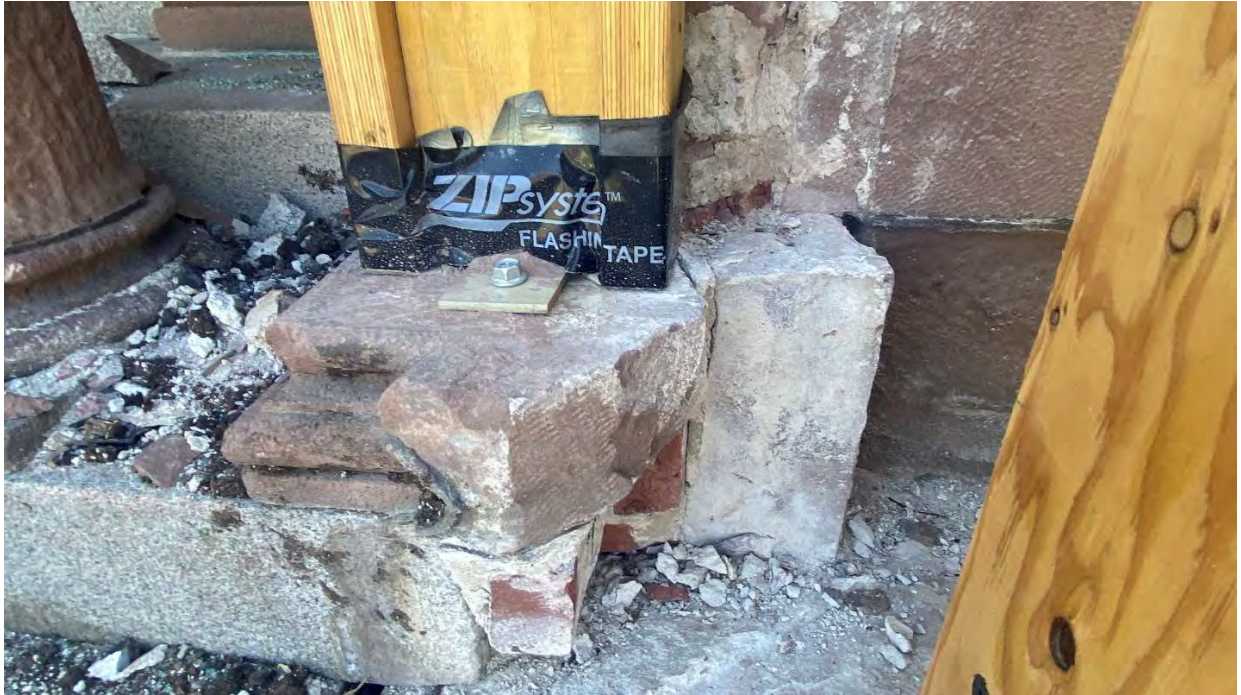
- Three wooden posts were installed in place of the broken columns and engaged pilaster prior to B+W's inspection. These posts are anchored with steel angles at the sill and head. A self-adhered membrane was installed at the base of these posts (Figure 10).

Figure 10. Temporary wood post with self-adhered membrane, anchored with metal angle to partial brownstone column base.

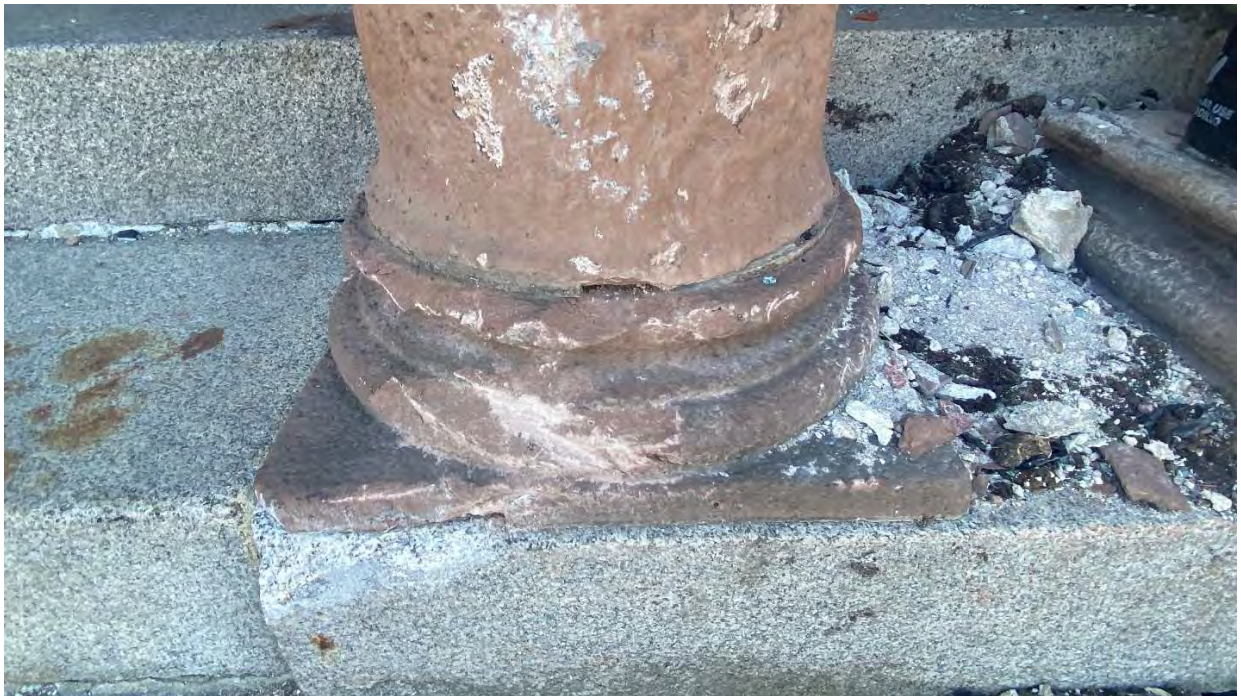
- The one remaining brownstone column on the west side of the entrance is broken with discolored scratches at the bottom half (Figure 11).
- Some of the brownstone remaining on the facade has cracked (Figure 12), spalled, or displaced, including at the base of the west end. At the return on the west end, there is a 12 inch by 15 inch incipient spall that has displaced several inches off the granite foundation unit below (Figure 13).

- Sections of several granite elements were spalled, such as a piece beneath the remaining west brownstone column (Figure 11) and one of the missing column plinths (Figure 18).

Figure 11. Broken masonry and discolored scratches on base of existing west end brownstone column.

- Grind down discolored scratches on remaining west brownstone column. If necessary, install patch to fill in profile of column if more than 1/4 inch depth of stone is ground off. Ensure that finished surfaces have stippled pattern to match existing, whether hand-chiseled on stone or cast on the surface of the patch.

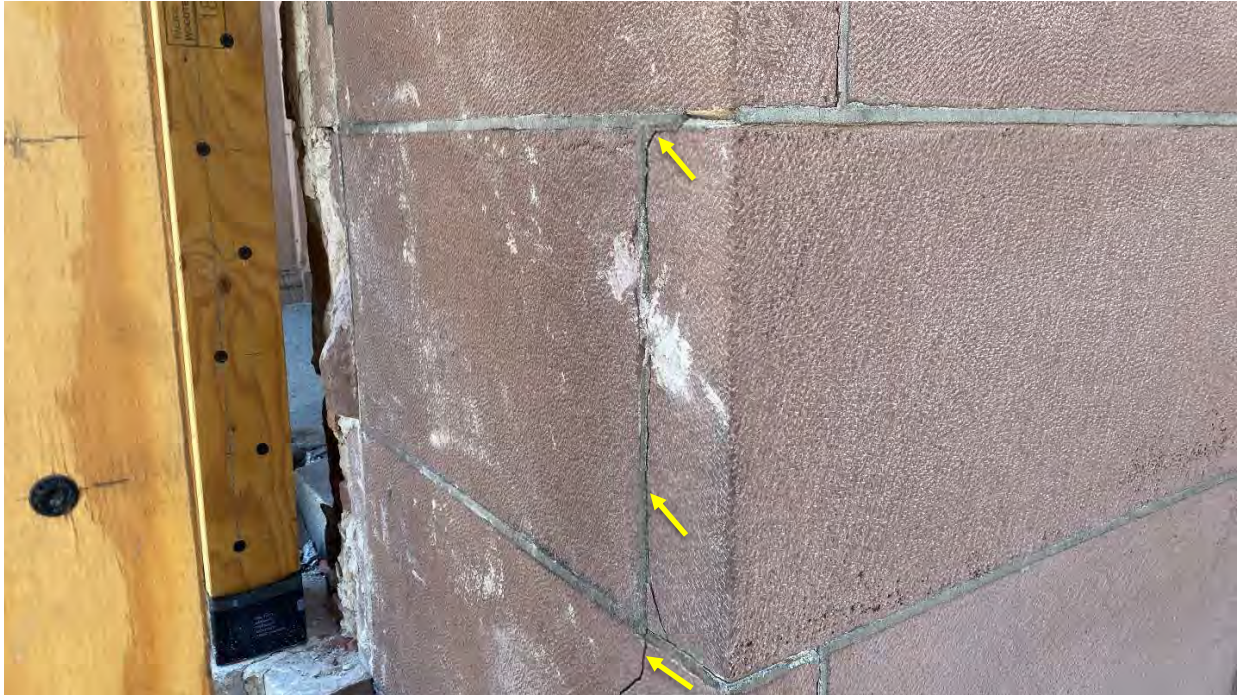
Figure 12. Cracks in brownstone facade behind missing columns.

- Repair cracks in existing brownstone facade by routing and sealing them. Repair lower spalls or incipient spalls (larger than 3 inches by 3 inches) with dutchman repairs anchored to parent stone with mechanical anchors. Repair lower spalls or incipient spalls (less than 3 inches by 3 inches) with patch repairs. Review each higher spall or incipient spall on an individual basis to determine if a patch or dutchman repair is most prudent.

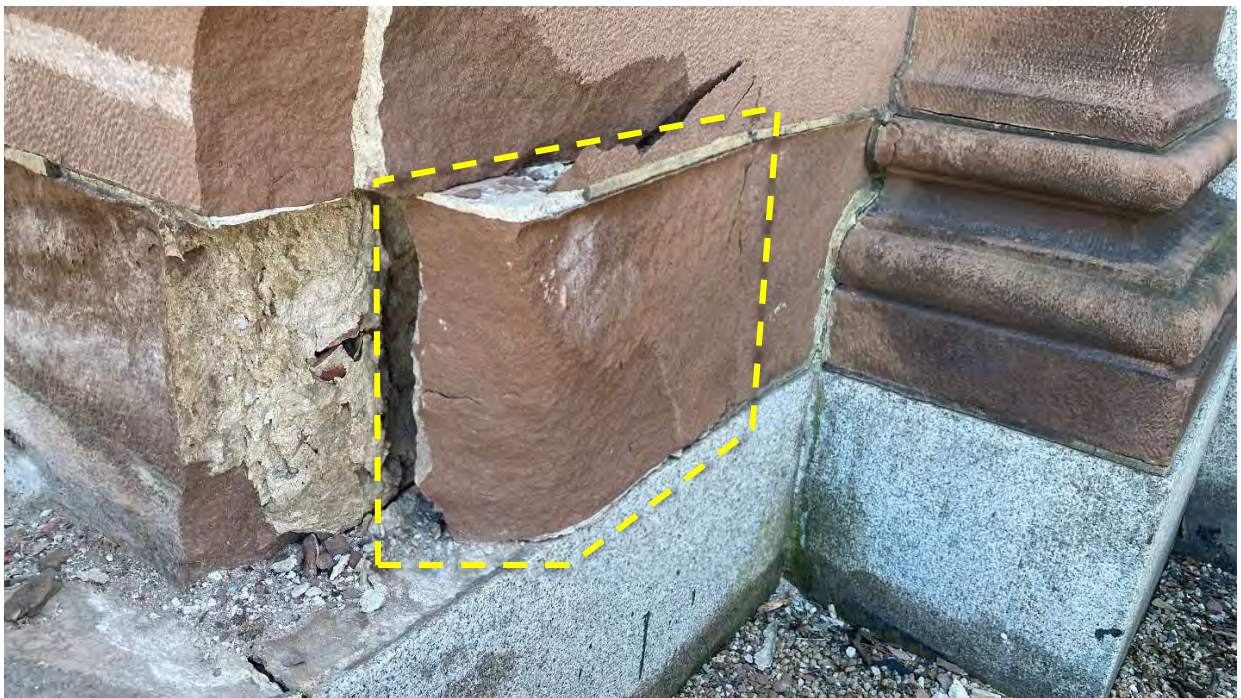
Figure 13. 12 inch by 15 inch brownstone return incipient spall.

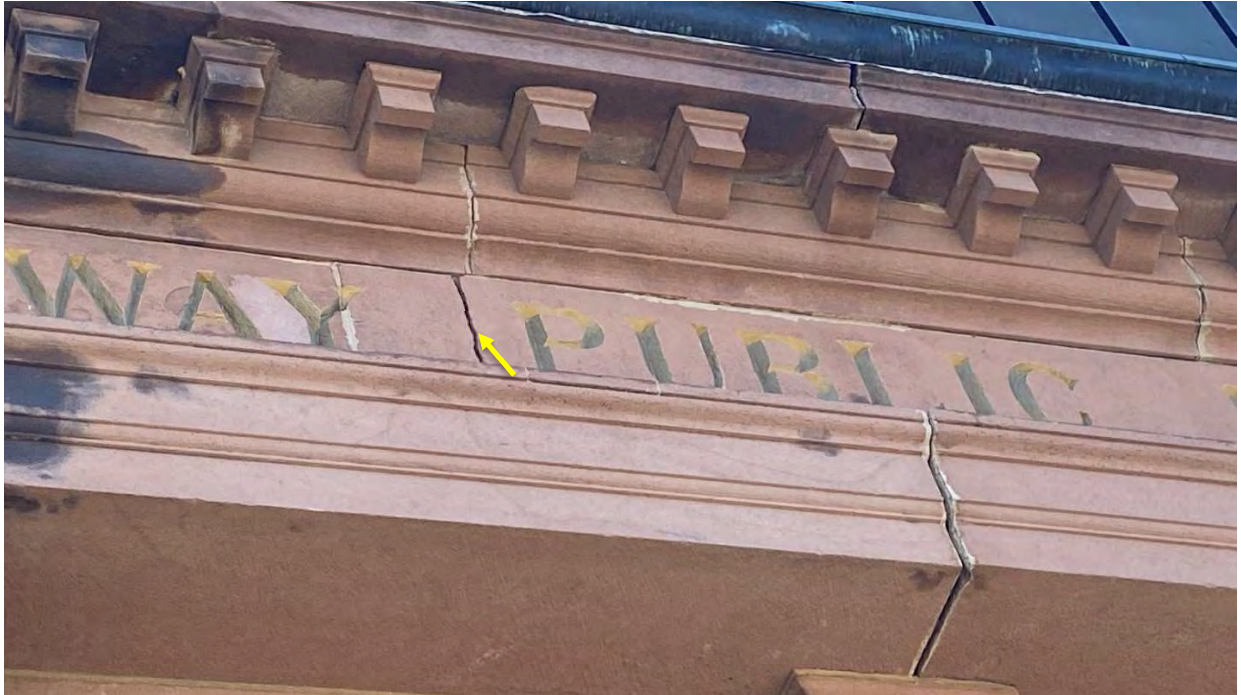
- There is a wide vertical crack in the frieze of the entablature between the words "CONWAY" and "PUBLIC" carved into the brownstone (Figure 14).
- The brownstone elements have a stippled carved surface finish (Figure 15).

Figure 14. Vertical crack in frieze of entablature.

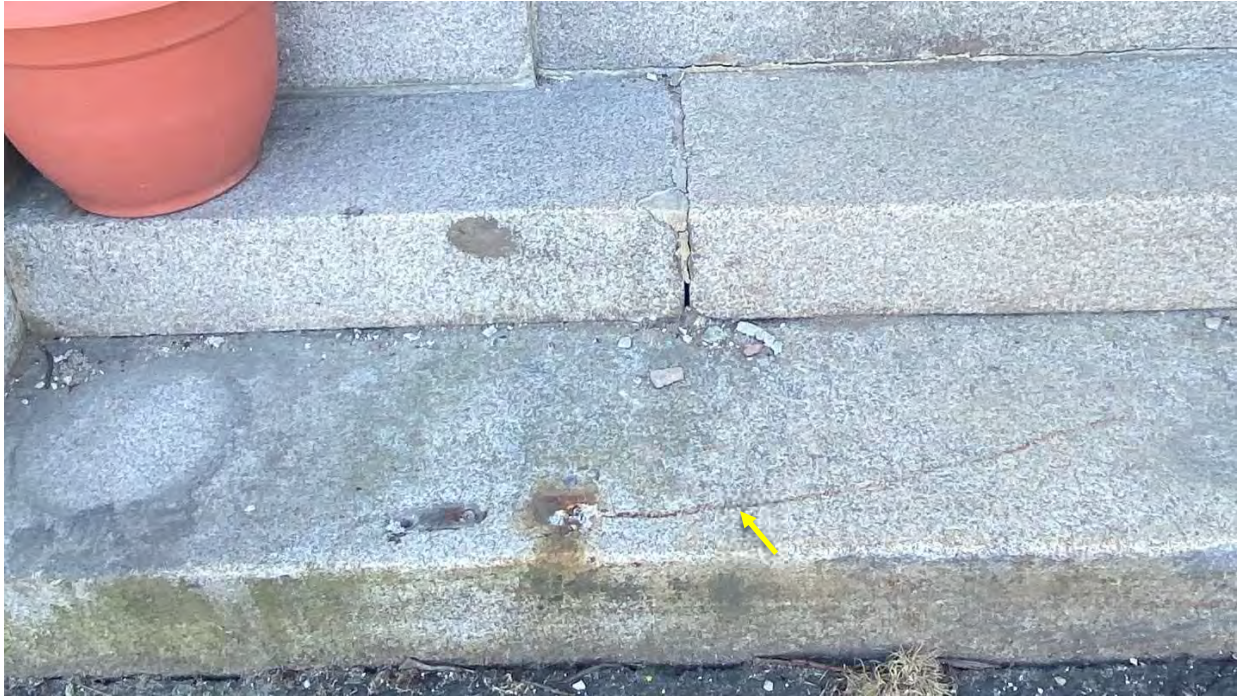
- The two iron railings broke off from their embeds at the granite stone steps and brownstone facade on either side of the door (Figure 16). Discolored scratches and spalled stone are present near the prior embed locations (Figure 17). These railings were not original to the building.

Figure 16. Scratch on granite step near embed to former iron railings.

- Consider a new railing design to match the design of the original construction. Embed railings at different locations from the original so that anchors are embedded in solid parent stone and bed in non-shrink grout.

- Clean all debris from entrance.
- Clean scratches and staining from granite where present.

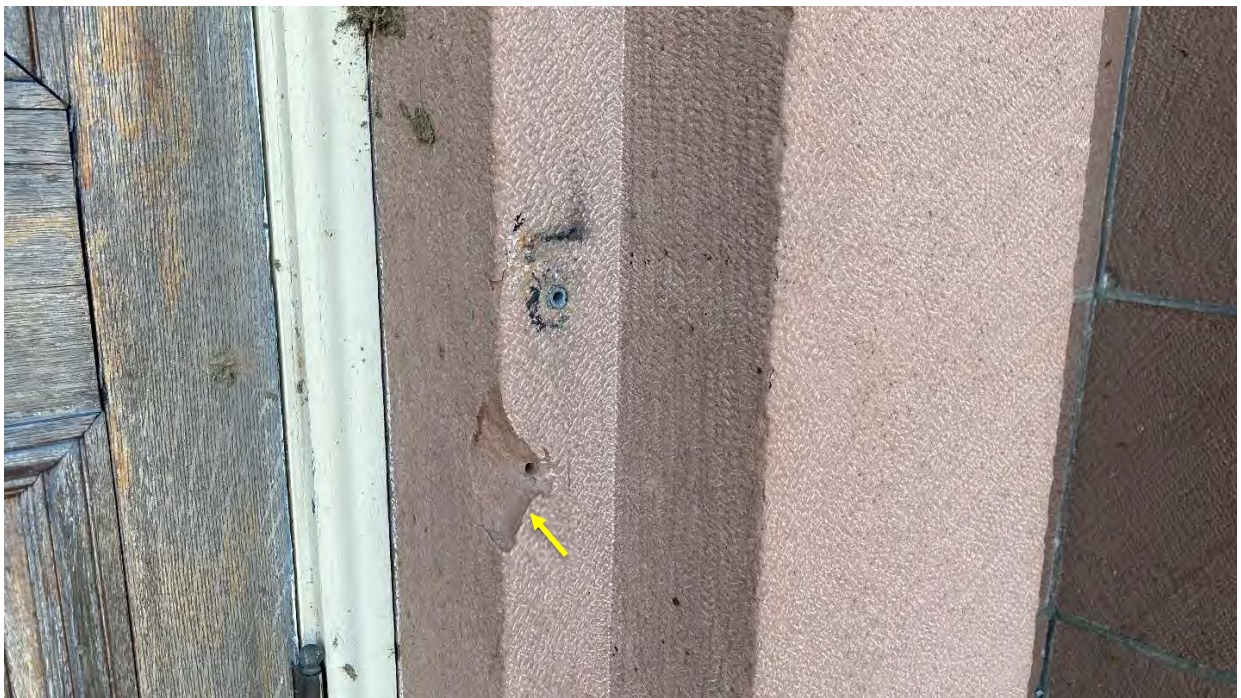
Figure 17. Spalled brownstone facade near former railing anchor embeds, adjacent to front entrance doors.

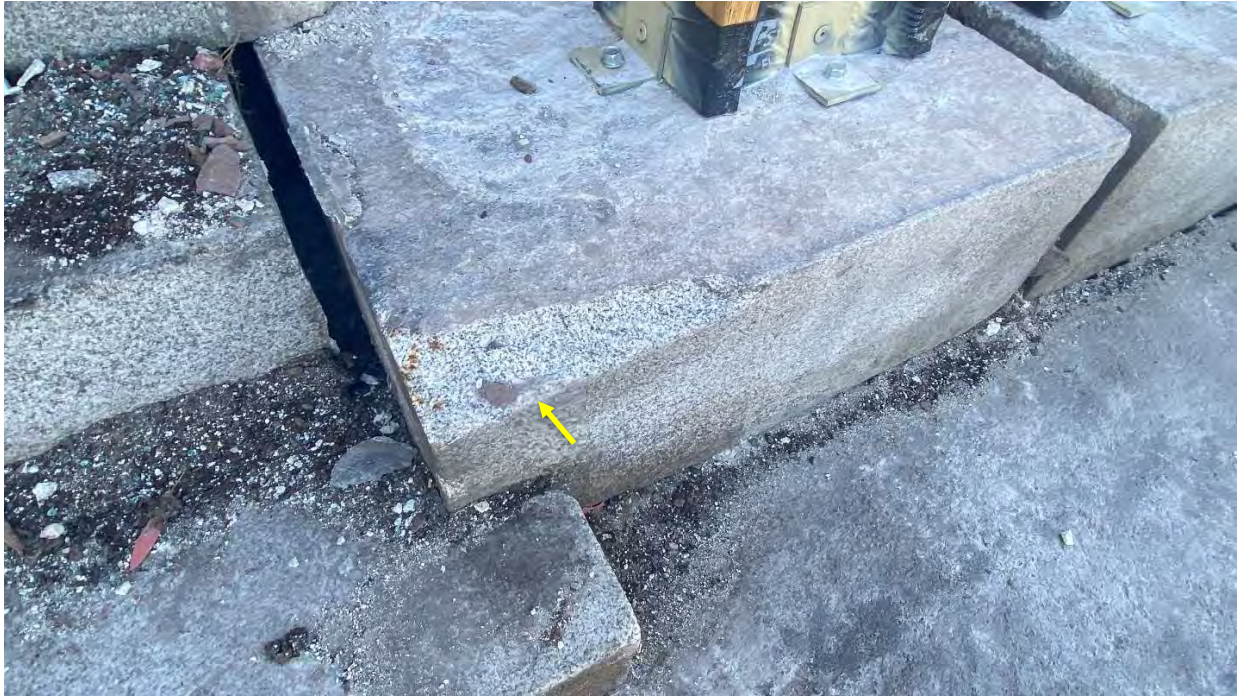
Figure 18. Spalled granite plinth which supported prior column.

- Reset granite column plinths (originally supporting the brownstone columns), and any other stone that has shifted, back to their original locations.
- Patch granite spalls where present.

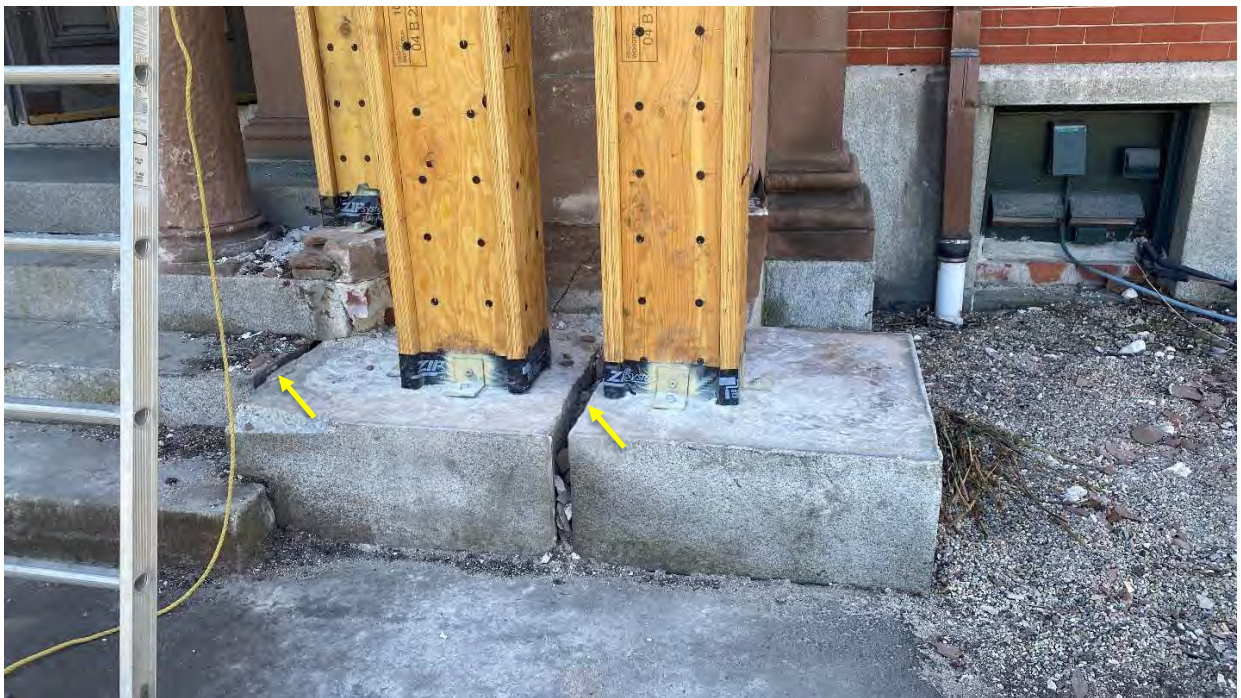
- Several units of stone have displaced, causing a void in the mortar joints (Figure 19 and Figure 21). The plinth units at grade (formerly supporting the two largest west columns) experienced the largest displacement, 1-3/4 inch (Figure 20) and 1-1/4 inch, both laterally to the west.

Figure 19. Displaced granite plinth units which support former columns.

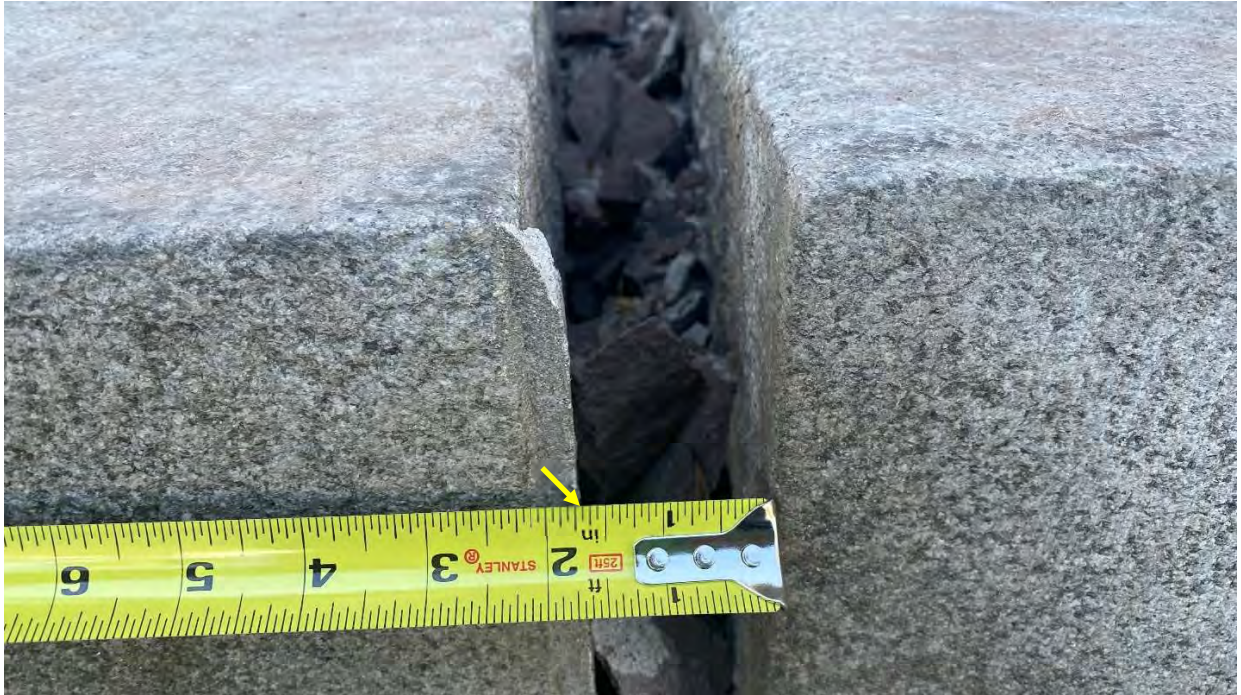
Figure 20. Additional 1-3/4 inch displacement between granite plinth units.

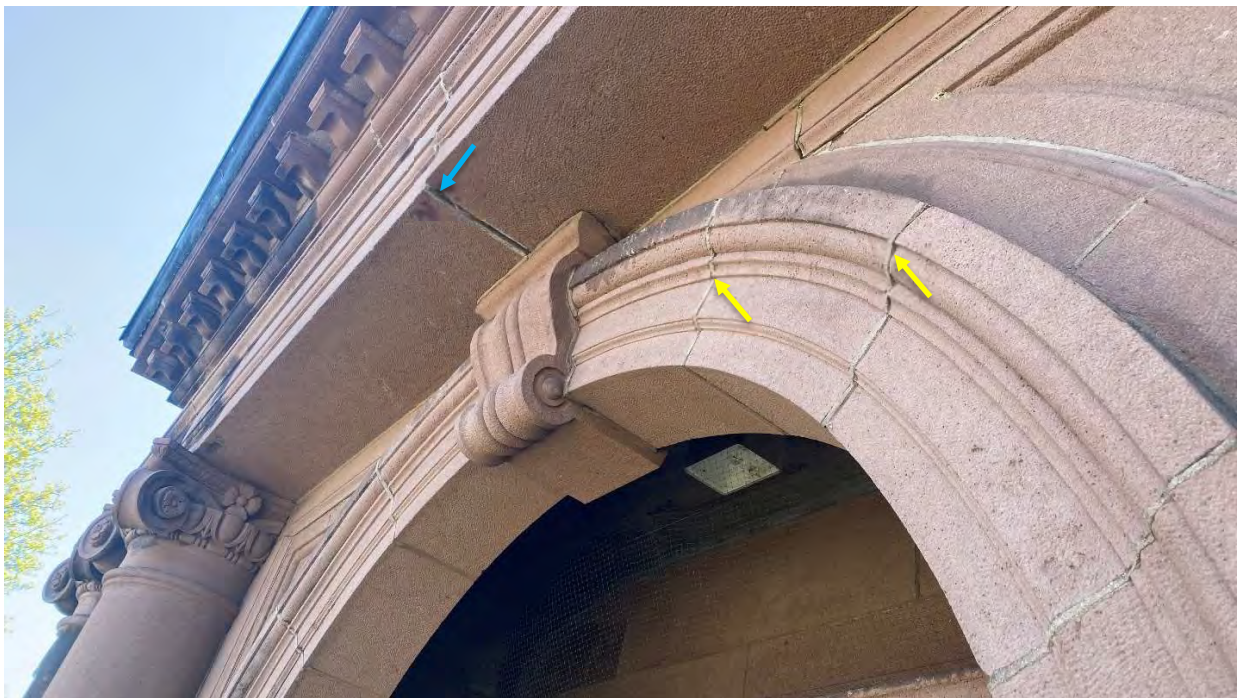
- Some mortar joints are displaced and project beyond the surface of the brownstone facade (Figure 21 and Figure 22).
- Some mortar, including mortar overhead appeared loose, but was not able to be removed from the facade by hand (Figure 23).

Figure 21. Displaced mortar (yellow arrows), protruding beyond the surface of the brownstone facade surface. Void in joints above arched opening (blue arrow).

- Remove mortar from entire entrance and install historically-appropriate mortar. Installing modern cementitious mortars can cause damage to the less porous stone.

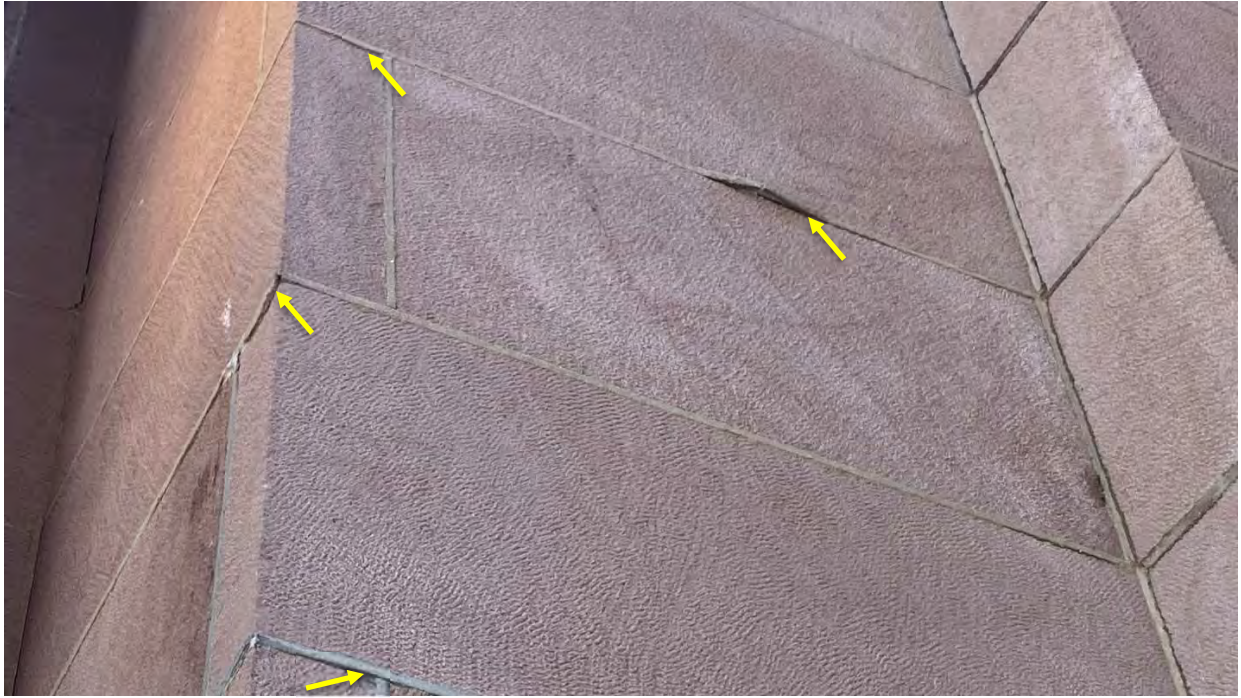
Figure 22. Displaced mortar, protruding beyond the surface of the brownstone facade surface.

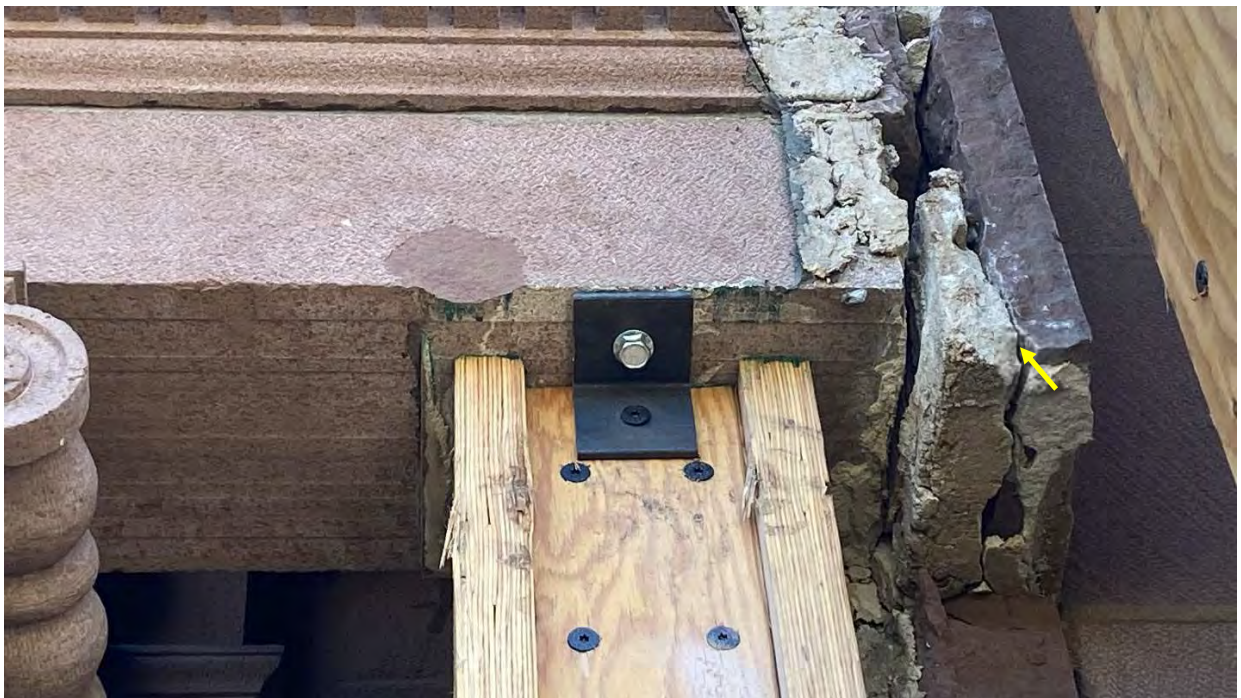
Figure 23. Exposed backup mortar appeared loose, but was not removable from the facade by hand.

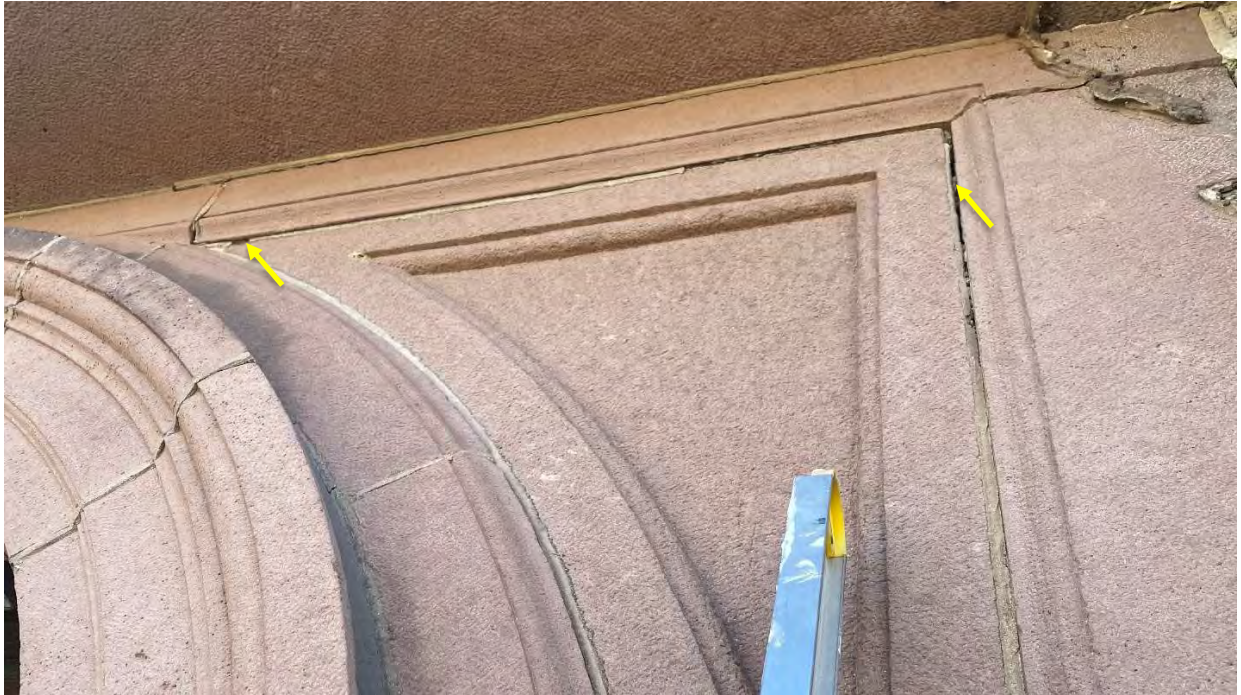
- Select mortar is missing from joints (Figure 24).
- B+W reviewed the interior surface of the masonry entrance. The backup walls behind the brownstone are composed of brick (Figure 25). Wood framing is installed above the masonry walls, which frames out the

Figure 24. Mortar missing from brownstone joints.
