CONDITION ASSESSMENT

Project: **Conway Public Library**
15 Greenwood Avenue
Conway, NH 03818

Date: June 9, 2022

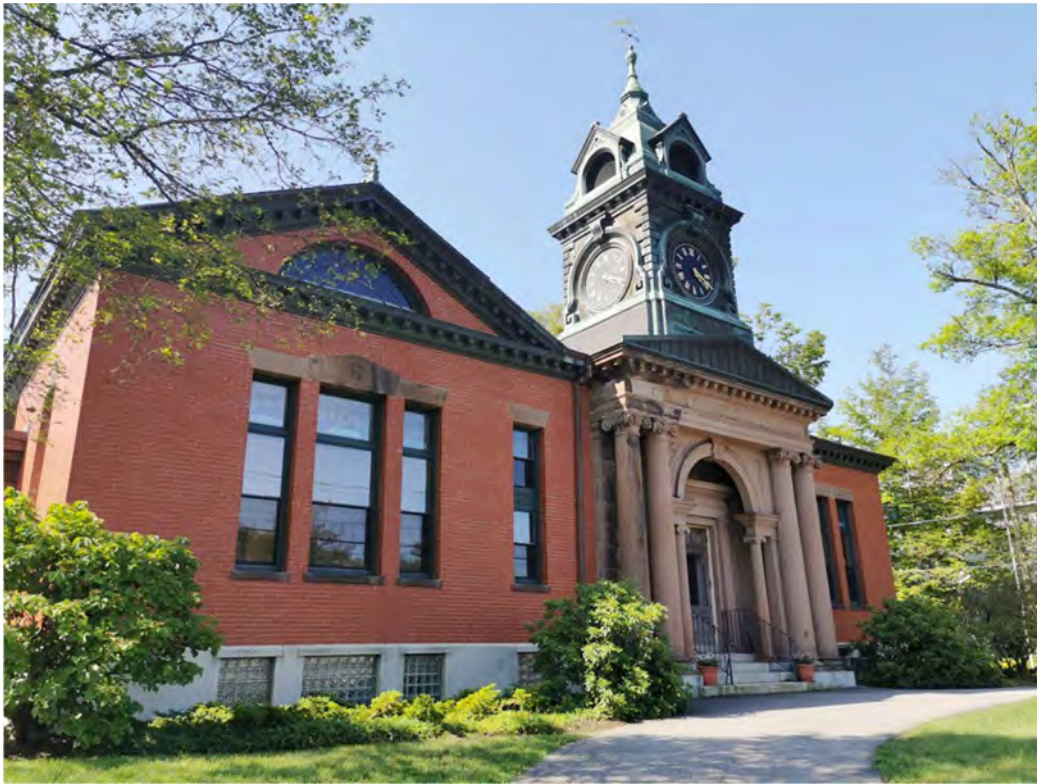
Figure 1. Conway Public Library north facade entrance circa 2014, prior to accident.

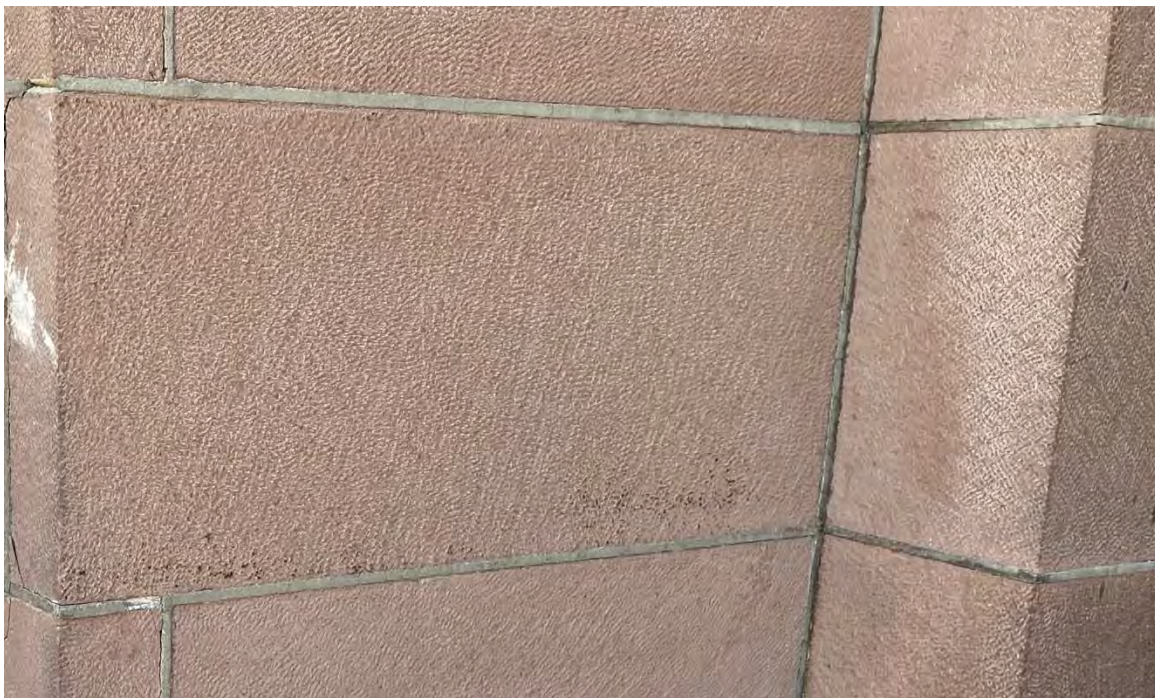
Figure 15. Stippled carved surface on existing brownstone surface.

- Similarly, complete patch repairs on column bases. Mechanical anchors are not required in this application as the patches are not overhead.
- Have column shafts fabricated in cast stone to replicate the dimensions and stippled carved surface texture of the originals. We recommend requiring the manufacturer to send samples and/or mockups of the cast stone to the library to be reviewed in different types of lighting to make sure they are a good match to the existing original brownstone.

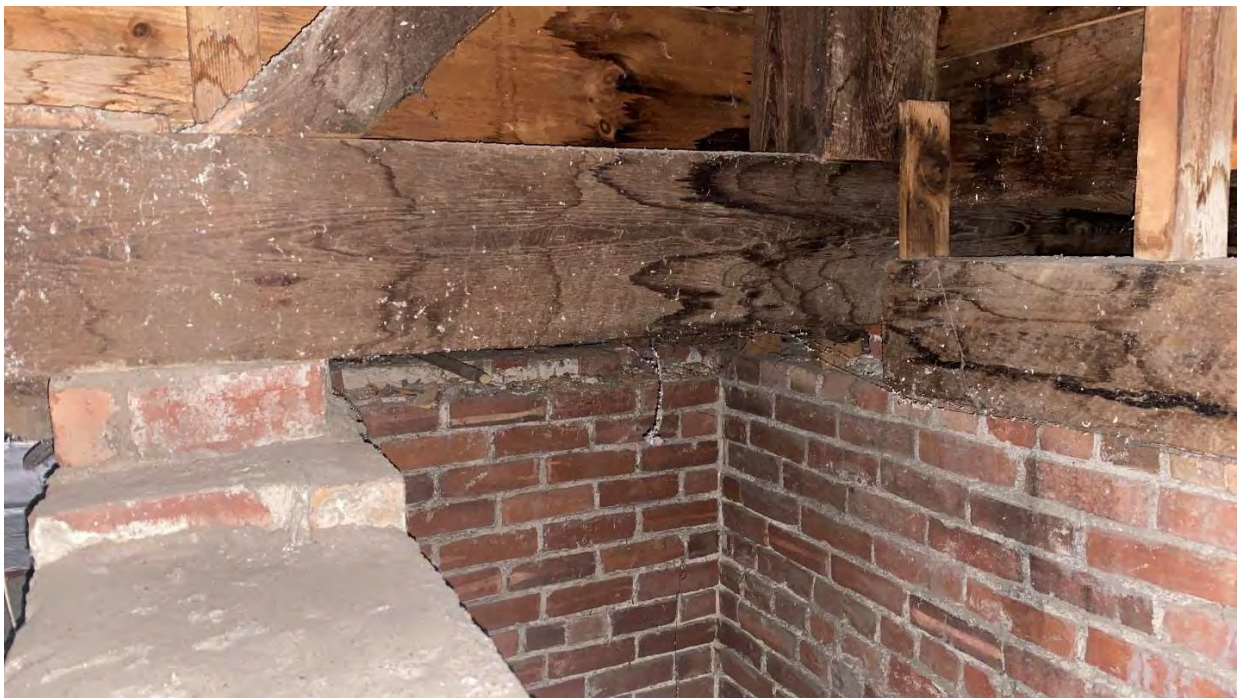
- Select mortar is missing from joints (Figure 24).
- B+W reviewed the interior surface of the masonry entrance. The backup walls behind the brownstone are composed of brick (Figure 25). Wood framing is installed above the masonry walls, which frames out the

Figure 25. Brick masonry backup walls above north entrance. Wood framing above.

- Remove mortar from entire entrance and install historically-appropriate mortar. Installing modern cementitious mortars can cause damage to the less porous stone.

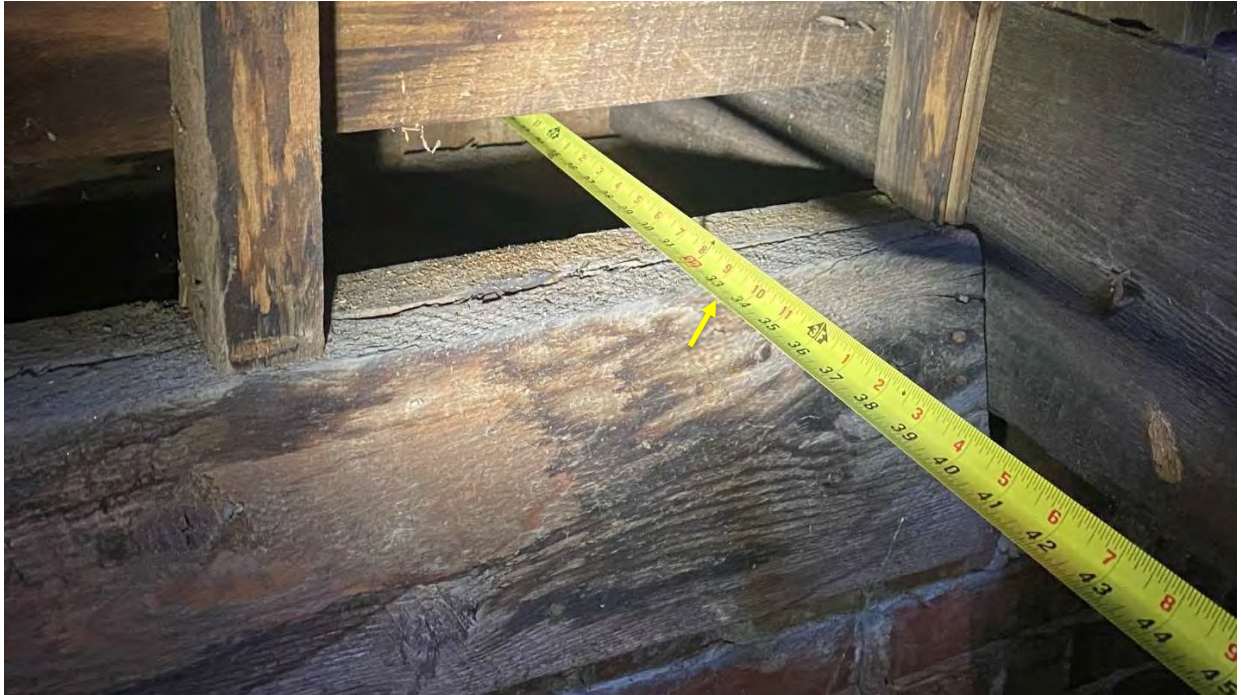
Figure 26. Two foot 9-1/2 inch distance from the interior face of the outer brick backup wall to the interior face of the inner backup wall.

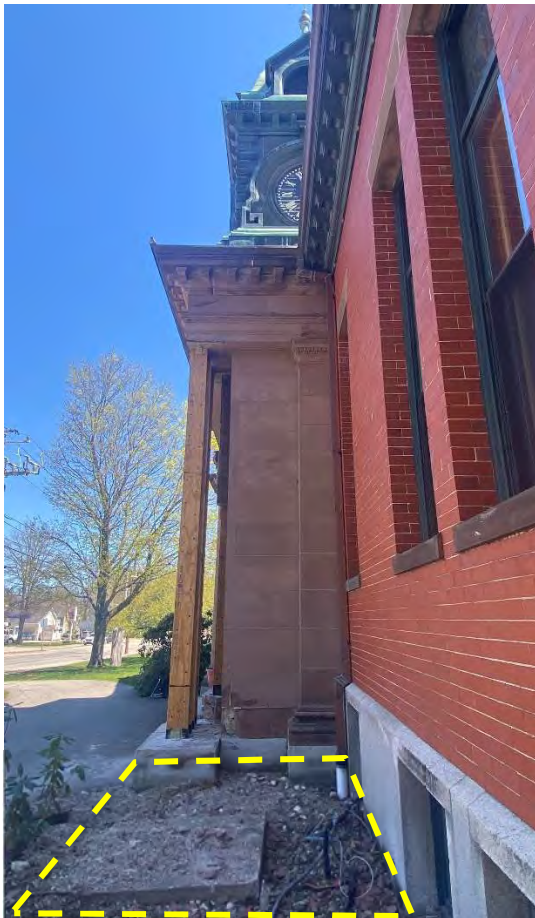
clock tower. There is roughly 2 feet 9-1/2 inches from the interior face of the outer brick backup wall to the interior face of the inner backup wall (Figure 26).

Figure 27. Area where prior bushes were removed west of entrance.
